Slip Test Report

BS 7976:2 PENDULUM SLIP TEST REPORT

RECYCLED PLASTIC DECK/BOARD SAMPLES

Company:
Plastecowood Ltd
2 Expressway Business Park,
Bodelwyddan,
LL18 5SQ

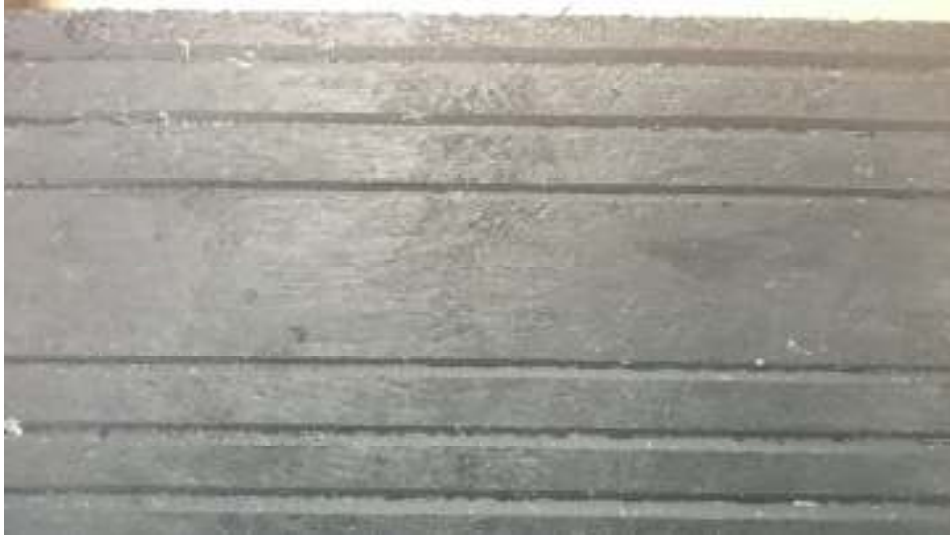
(#1) Sample 1

A black, grooved sample piece of recycled plastic lumber deck/ board is tested in wet & dry conditions.

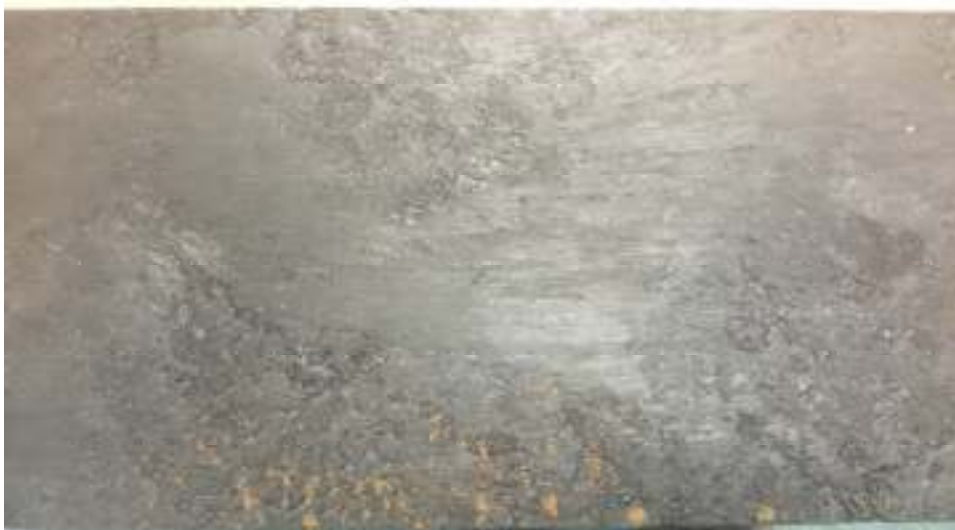
(#2) Sample 2

The same material is noted as the one above but this sample this has not got the grooves/ribbed feature therefore creating a smooth, seamless attribute which could be easily kept clean and inhibit the rapid growth of lichen, moss, algae as opposed the above sample.

It is my opinion that Sample #2 could be easily kept clean, if appropriate cleaning measures are adopted by the client/end user.

If these products are specified for typical external applications, seasonal and weather conditions need to be taken into consideration to minimise slip risks. Whilst sample no 2 is less likely to retain water, ice, moss or lichen and will dry more quickly, additional mitigation measures such as grit or rocksalt are recommended, whenever required.
